NASA Technical Memorandum 79277

**CHARACTERIZATION AND PROPERTIES OF
CONTROLLED NUCLEATION THERMOCHEMICAL
DEPOSITED (CNTD) SILICON CARBIDE**

**Prepared for the
Eightieth Annual Meeting of the Basic Science Division
of the American Ceramic Society
Detroit, Michigan, May 6-11, 1978**

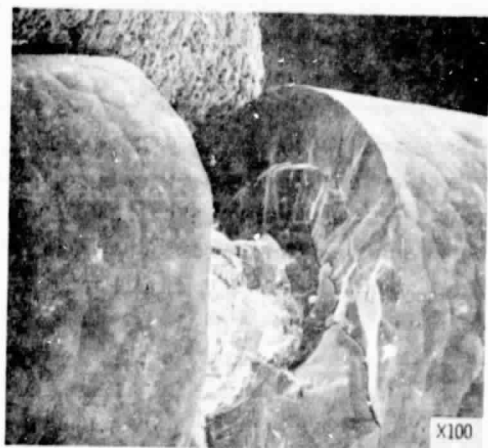
Figure 10. - SEM of as-deposited CNTD - SiC rod fractured at 1380°C showing cracks in SiC σ_f ~ 169 ksi (1167 MPa).
